1. Report No. NASA CR- 134735	2. Government Accession No.	3. Recipient's Catalog No.	
4. Title and Subtitle  Coatings for Directional Eutectics		5. Report Date October, 1974

14. Sponsoring Agency Code	
15. Supplementary Notes Project Manager, John P. Merutka, NASA Lewis Research Center, Cleveland, Ohio			
16. Abstract  Eleven coating systems based on MCrAlY overlay and diffusion aluminide prototypes were evaluated to determine their capability for protecting the $\gamma/\gamma' - \delta$ (gamma/gamma prime-delta) directionally solidified eutectic alloy (Ni-20Cr-6Cr-2.5Al) in gas turbine engine applications. Furnace oxidation and hot corrosion, Mach 0.37 burner-rig, tensile ductility, stress-rupture and thermomechanical fatigue tests were used to evaluate the coated $\gamma/\gamma' - \delta$ alloy. The diffusion aluminide coatings provided adequate oxidation resistance at 1144°K (1600°F) but offered very limited protection in 1144°K (1600°F) hot corrosion and 1366°K (2000°F) oxidation tests. A platinum modified NiCrAlY overlay coating exhibited excellent performance in oxidation testing and had no adverse affects upon the eutectic alloy in tensile ductility, stress-rupture and ther

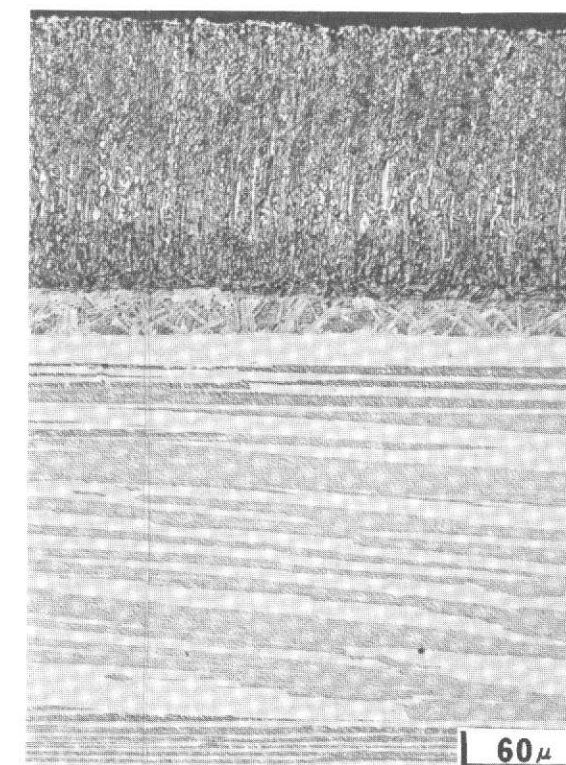
CoNiCrAlY

Figure 7 Post-Test Microstructural Condition of e.b. Overlay Coatings Which Were Exposed for 260 Hours in the 1144° K (1600°F) Laboratory Hot Corrosion Test

The results of the hot corrosion test are summarized in Table V. As suggested by the weight change results, all of the overlay coatings provided adequate protection during the course of this test. Moreover, in almost every instance, the reproducibility of the test results was excellent. Metallographic examination of the test specimens revealed attack to be minimal and uniform as illustrated in Figures 7 and 8.

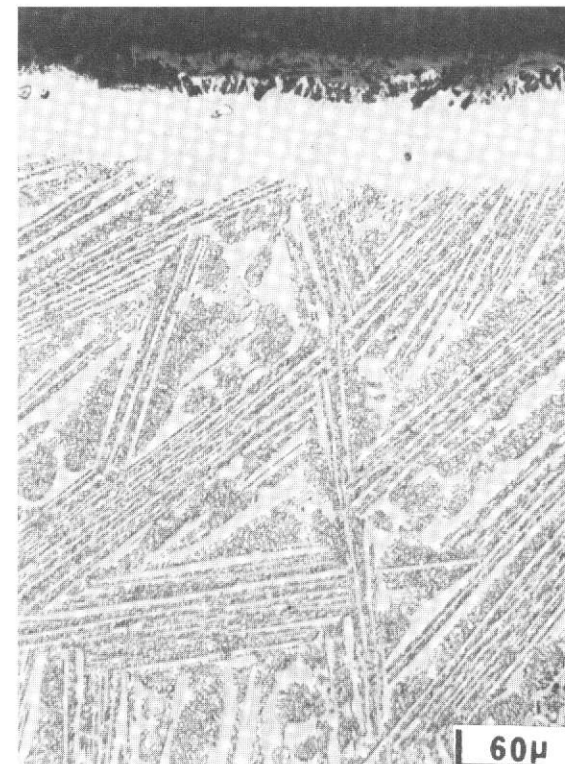
UNCOATED  
40 HOURS

Figure 18 1366°K (2000°F) Cyclic Oxidation Behavior of Diffusion Aluminide Coated and Uncoated Eutectic Alloy Coupons After Exposure for the Times Indicated. The Ni/Cr/Al Coating was Initially Approximately Twice the Thickness of the Cr/Al Coating.

The diffusion aluminide coatings were severely degraded after only relatively short exposures at 1366°K (2000°F). In fact, little or no ductile aluminide (Cr/Al) coating remained after only 100 cycles at 1366°K (2000°F). The Ni/Cr/Al coating was in somewhat better condition after 140 cycles, but certainly was not adequate at this temperature. This coating was the thicker of the two in the as-coated condition. Microstructures for these specimens and an uncoated eutectic alloy specimen which was exposed at 1366°K (2000°F) for 40 hours are shown in Figure 18.

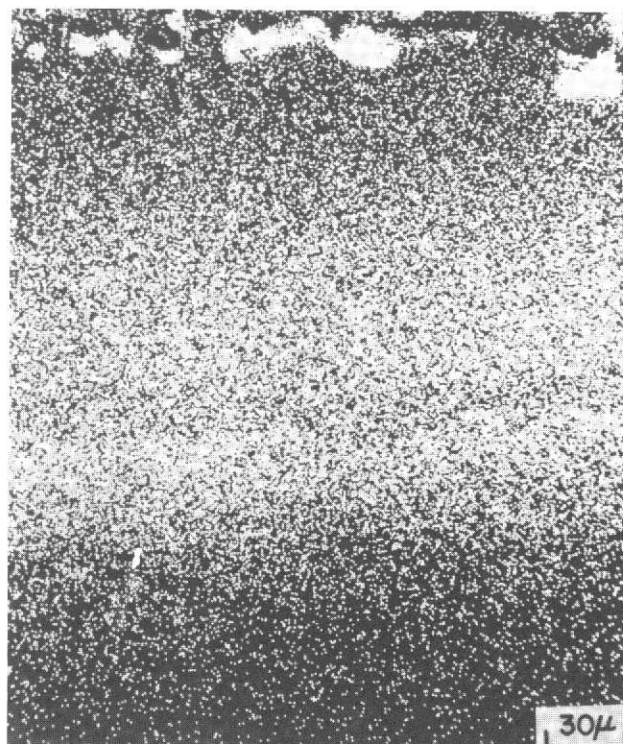
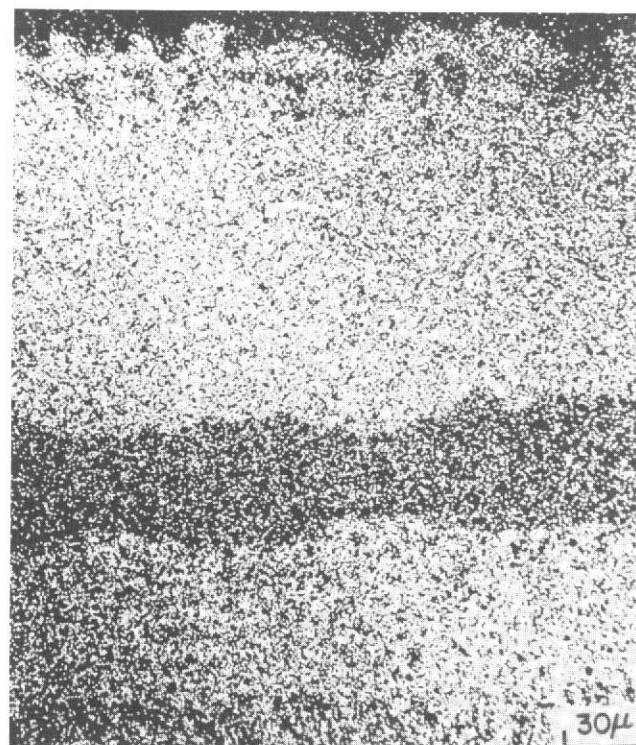
Figure 34 Electron Microprobe Photomicrographs of a D.S. Eutectic Alloy – NiCrAlY/Pt Coated Specimen After 100 – 1 Hour Cycles at 1478° K (2200°F).

The electron microprobe photomicrographs obtained for the specimen oxidized for 100 one-hour cycles at 1478°K (2200°F) are shown in Figure 34. Similar trends were observed in this specimen as were noted for the 1366°K (2000°F) specimen. In this specimen, however, the particles just below the external surface were found to be Al-rich and are presumably Al<sub>2</sub>O<sub>3</sub>.

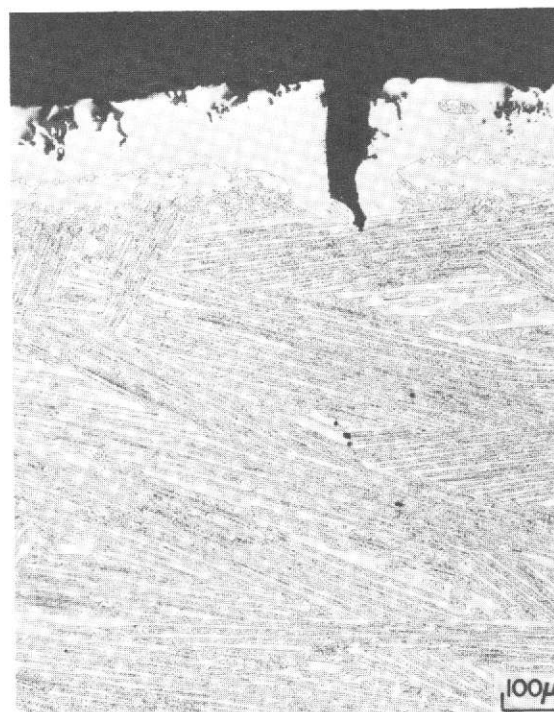
Figure 46 Surface Appearance of Thermal Fatigue Cracks in the Leading Surface of NiCrAlY/Al Coated  $\gamma/\gamma' - \delta$  Erosion Bar (R-7406) After 89, 493 and 1016 Hours of Testing in the Burner Rig 1366° K (2000°F) Cyclic Oxidation Test. Post-Test Examination of This Region Shows Crack Propagation into the  $\gamma/\gamma' - \delta$  Substrate.

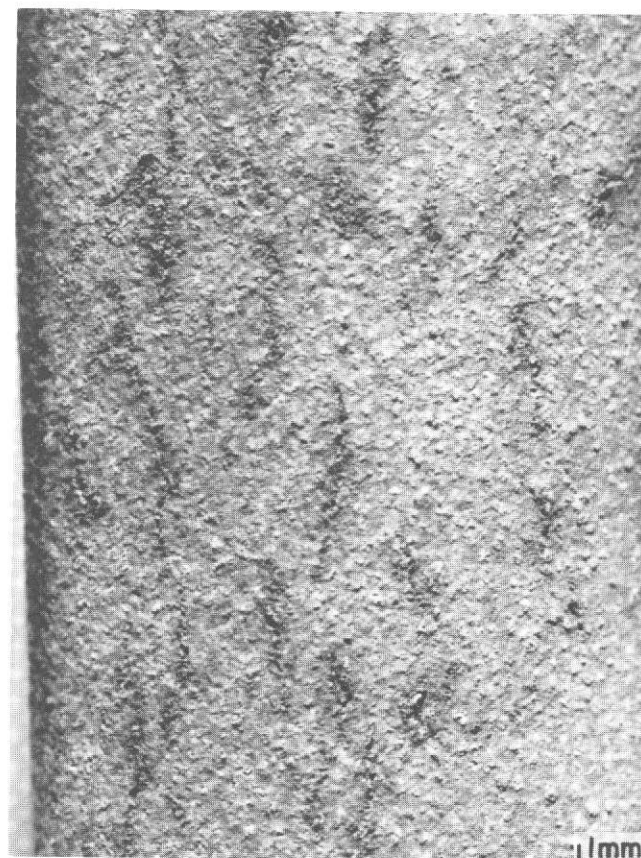
Figure 47 Surface Appearance of Thermal Fatigue Cracks in the Trailing Surface of NiCrAlY/Al Coated  $\gamma/\gamma' - \delta$  Erosion Bar (R-7406) After 818 (Left) and 1016 Hours (Right) of Testing in the Burner Rig 1366°K (2000°F) Cyclic Oxidation Test. Cracks Appear to be Developing into Localized Oxidation Failures. Post-Test Metallographic Examination of this Area (Figure 48) Indicated that the Coating Cracks Propagated into the  $\gamma/\gamma' - \delta$  Substrate.

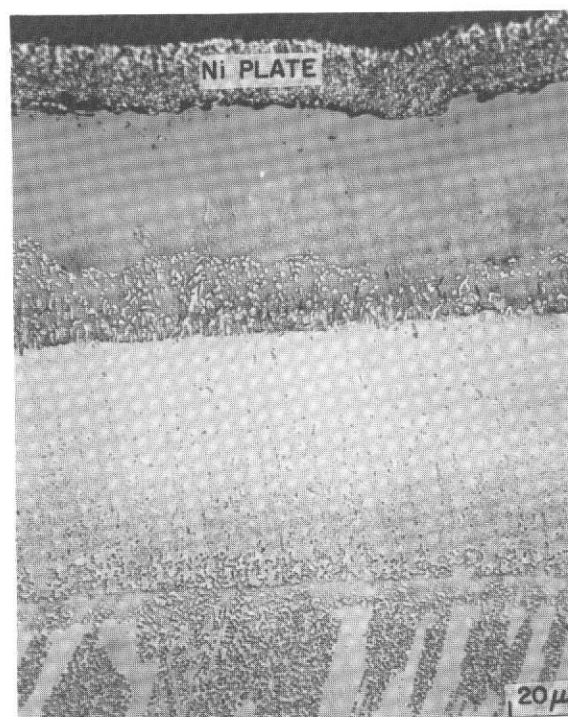
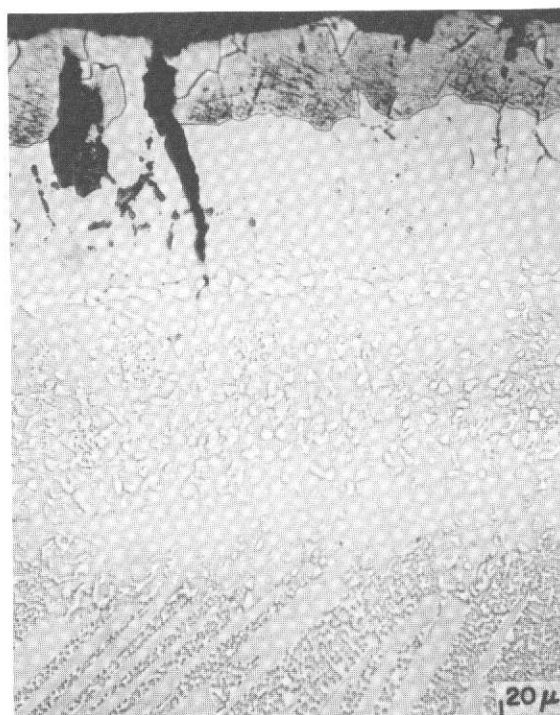
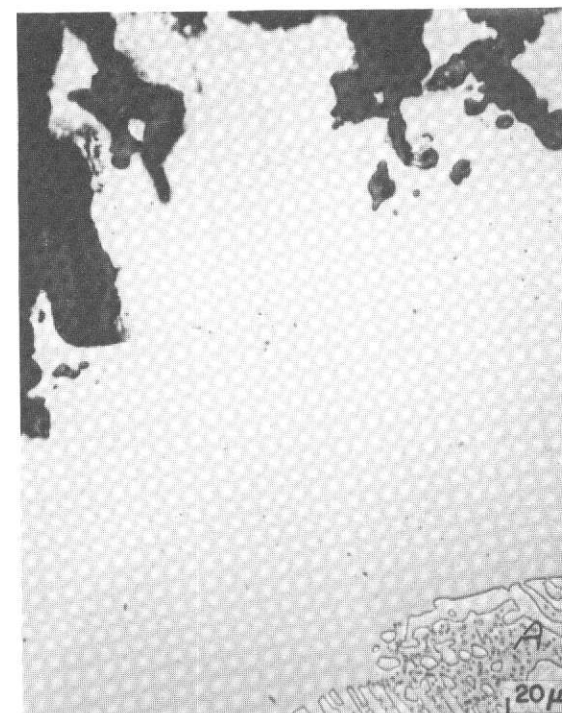
Figure 48 Pre-Test and Post-Test Microstructures of Ni-17.2Cr-6.2Al-0.58Y (Overlay) + Al (Pack) Coated  $\gamma/\gamma' - \delta$  Specimen (R-7406) Which was Tested for 1016 Hours in the Burner Rig 1366°K (2000°F) Cyclic Oxidation Test (Cycle: 55 Minutes Hot — 5 Minutes Forced Air Cool). Surface Appearance of Hot Zone Coating Cracks is Provided in Figure 47.

During visual inspection of the NiCrAlY/Al coated  $\gamma/\gamma' - \delta$  specimens, repeated spallation of the alumina scales and rather extensive thermal fatigue cracking of the coating were observed. These cracks were oriented primarily axially (parallel to the solidification direction of the erosion bar). The most severe thermal fatigue cracks in the NiCrAlY/Al coated erosion bars were in the leading surface (surface of smallest arc) of specimen R-7406. Isolated cracks were detected as early as 89 hours. Progressive development of these cracks is shown in Figure 46. Cracking was also extensive in the trailing surface (surface of largest arc) of this specimen as shown in Figure 47. Metallographic examination of these specimens showed that the thermal fatigue cracks had propagated a short distance into the substrate (see Figures 46 and 48).

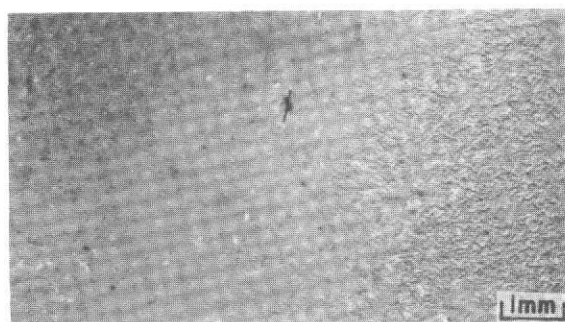
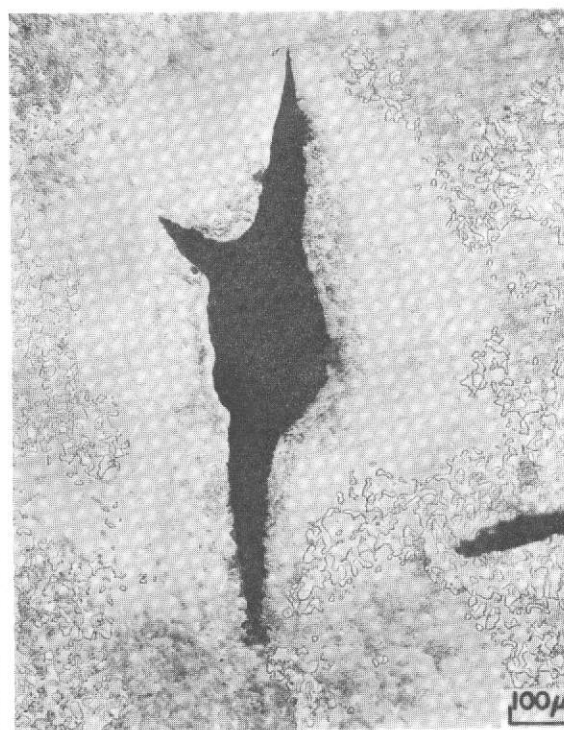
Figure 57

Surface Appearance (left) of the Largest Thermal Fatigue Crack (Which Initiated at a Coating Pit) in NiCrAlY/Pt Coated  $\gamma/\gamma'$ - $\delta$  Erosion Bar (R-7414) Which Was Evaluated for 1016 Hours in the Burner Rig 1366°K (2000°F) Cyclic Oxidation Test. Post-Test Planar (Center) and Cross Section (Right) Microstructures Indicate That the Coating is Locally depleted Adjacent to the Crack and That the Crack had not Propagated Through The Diffusion Affected Substrate Layer

Thermal fatigue cracking was minimal in the NiCrAlY/Pt coated  $\gamma/\gamma'-\delta$  specimens and absent in the NiCrAlY/Pt coated PWA 1422 specimens. The largest thermal fatigue crack observed in a NiCrAlY/Pt coated  $\gamma/\gamma'-\delta$  specimen (R-7414) is shown in Figure 57. Post-test metallography indicated that the crack had not propagated through the diffusion affected substrate layer.
